### Introduction

## Newsletter no. 3

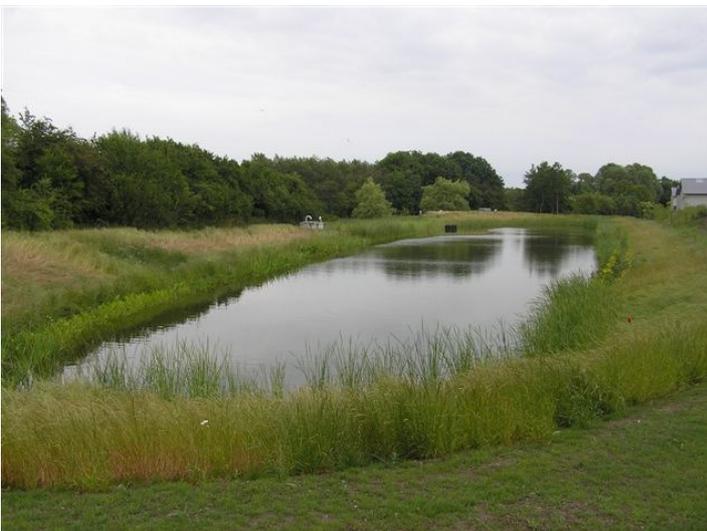
Photos from the end of June 2008.  
Photo above shows the pond viewed from the inlet structure.

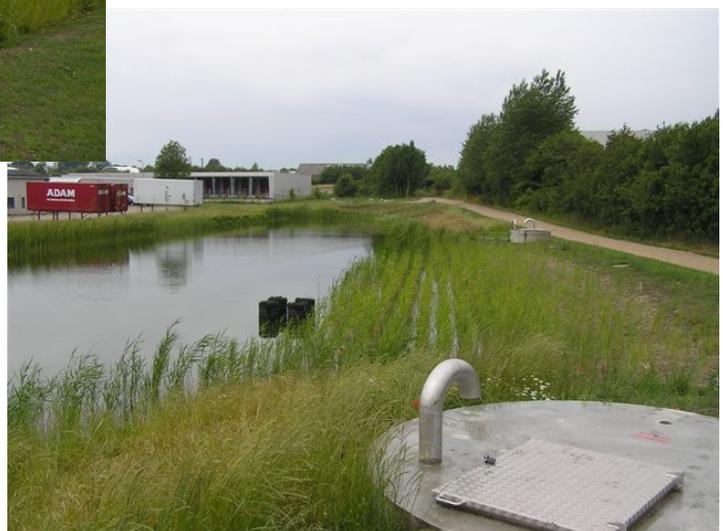
To the right the view is from the outlet end. The black cylinders in the pond are the vertical sand filters.

The structure in the front is the flow meter unit. Flows through the various filters are measured separately.

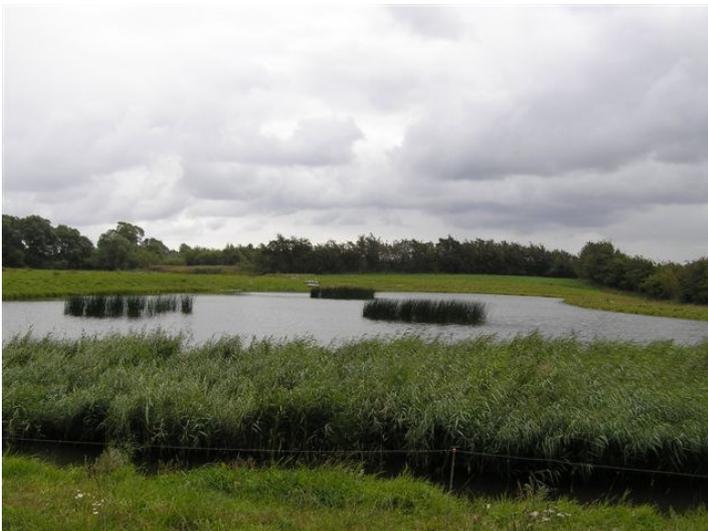
Photo above from September 2008 shows the pond from the outlet structure.

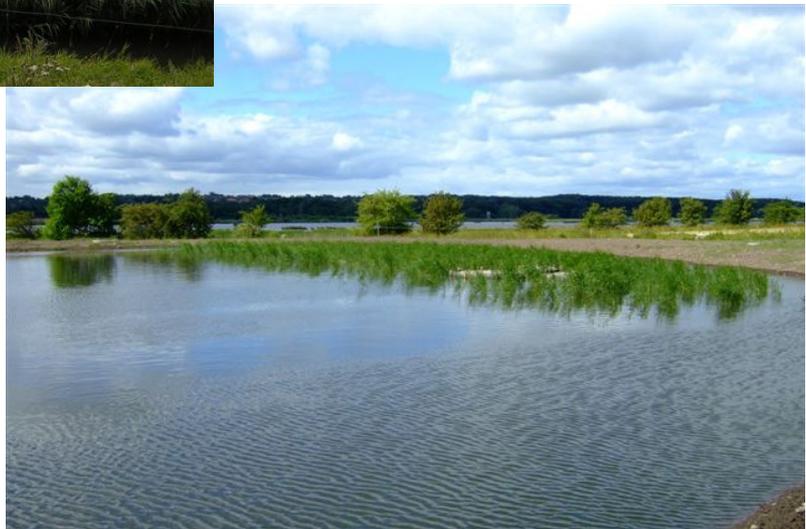
Photo at the right is from June 2008. The vertical sand filters are dimly seen in the reed vegetation and in the background Lake Brabrand.

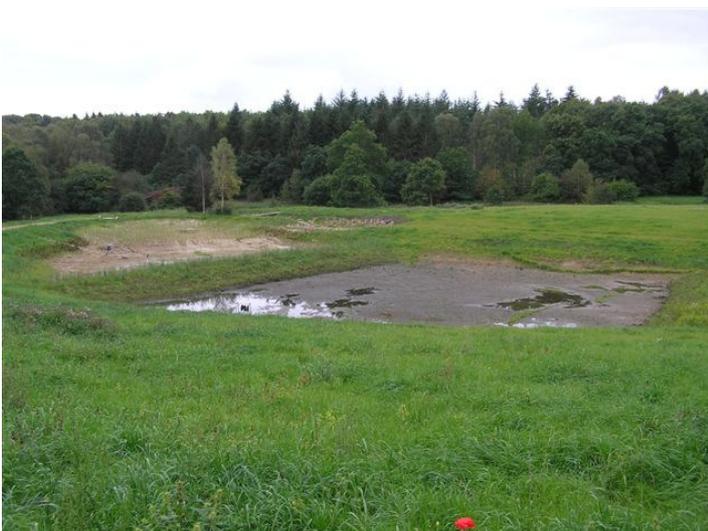
Photo above shows the problem in Silkeborg, the mid section without water. Additional clay is expected to reestablish impermeability.

The construction of the facility in Silkeborg was of various reasons delayed. Unexpected mollic soil conditions (organic silt / peat) and extraordinary amounts of precipitation caused severe problems with construction of the clay membrane during the winter season. The problems were solved and the construction works were completed in the beginning of May. The facility was fully equipped and tested in the middle of May and put on line to receive storm water. Unfortunately this was the at the beginning of a 6-8 weeks period with no precipitation in the region. The draught resulted in an arid and cracked clay membrane in the mid section of the pond. More clay has been added but the mid section is not yet tested impermeable. The demonstration facility is now expected to be ready for performance verification at the end of October 2008.

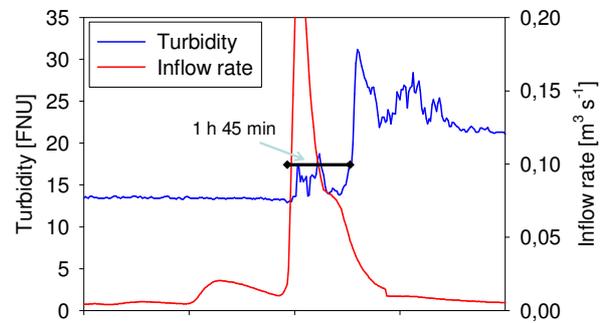
Figure 1 Time delay from start of inflow event to response in pond turbidity.

Monitoring at the facilities in Odense and Aarhus has advanced sufficiently to allow a preliminary assessment of the sedimentation performance. One important result at this stage is that the ponds behave as completely mixed reactors as opposed to plug flow reactors. This has been concluded from analyzing the response of pond turbidity to stormwater inflow (Figure 1). This understanding has significant impact on understanding sedimentation physics in stormwater ponds and consequently on design procedures for sedimentation ponds.

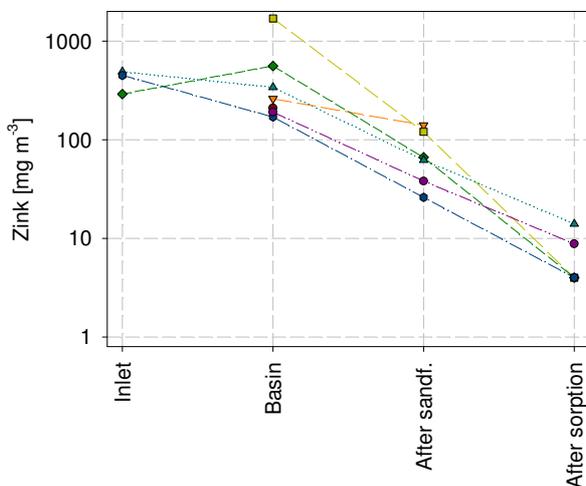
Figure 2. Removal of zinc at the facility in Odense

With respect to the sorption technologies, only the facility in Odense allows for a preliminary assessment of the filter performance. The reason here for is that the facility in Aarhus is still operated without iron enrichment of the bottom sediments in order to achieve a stable baseline of pollutant removal measurements, and because full monitoring of the facility in Silkeborg has not yet commenced due to technical problems mentioned previously in this report. However the efficiency of the filters in Odense has proven to be excellent. See for example the removal of zinc, Figure 2, or copper, Figure 3, where the filters reduce residual concentrations by a factor 5-10.

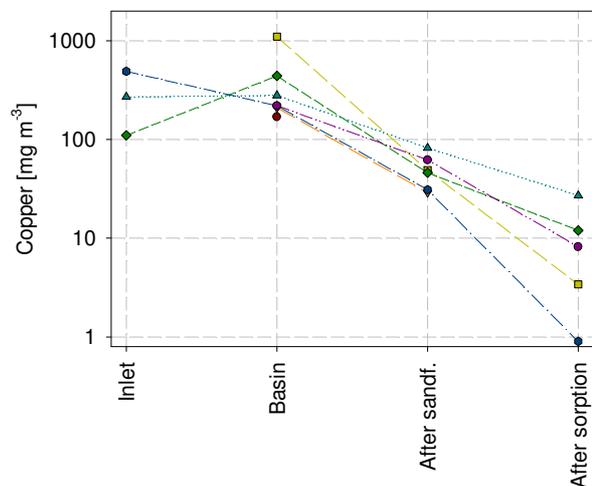
Figure 3. Removal of copper at the facility in Odense
